INDOOR AIR QUALITY ASSESSMENT

**Northbridge Middle School
171 Linwood Avenue
Whitinsville, MA 01588**

Prepared by:
Massachusetts Department of Public Health
Center for Environmental Health
Emergency Response/Indoor Air Quality Program
August 2005

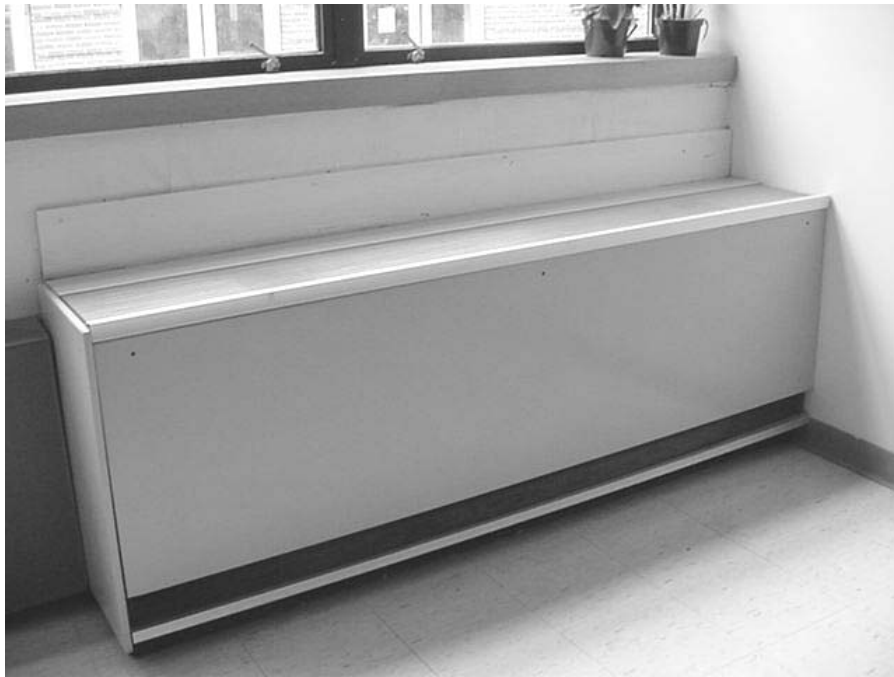
Picture 1

Fresh air in classrooms is supplied by unit ventilator (univent) systems (Picture 1). A univent draws air from outdoors through a fresh air intake located on the exterior wall of the building (Picture 2) and returns air through an air intake located at the base the unit ([Figure 1](#)). Fresh and return air are mixed, filtered, heated and provided to classrooms through an air

Classroom univent

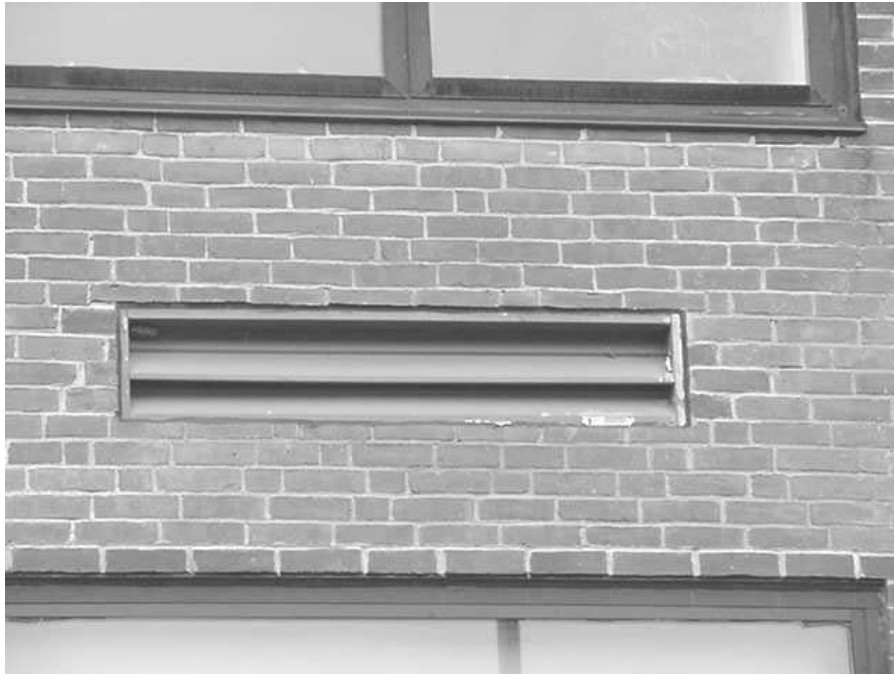
Picture 2

Univent fresh air intake on exterior wall

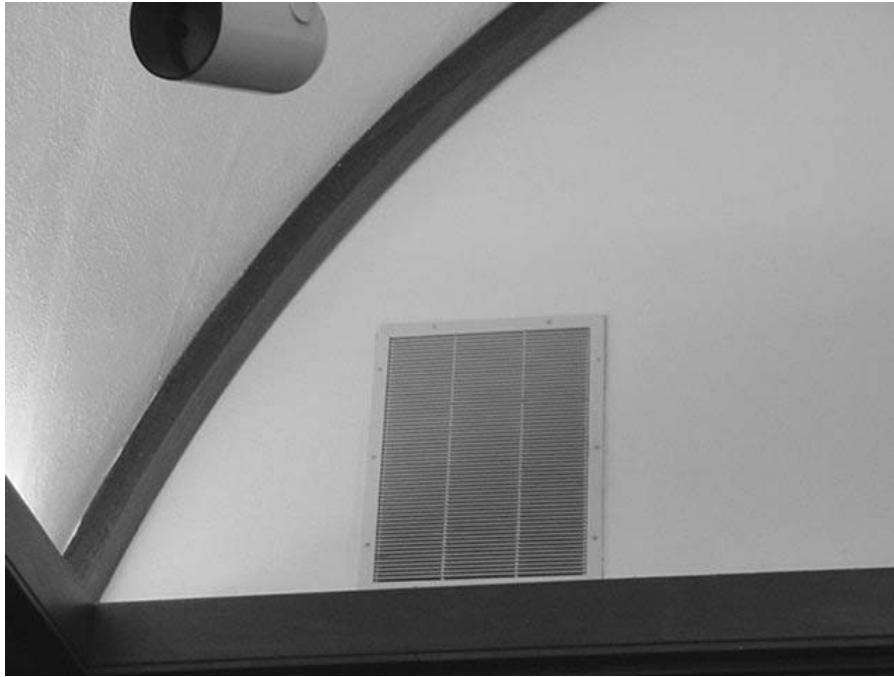
Picture 4

Mechanical exhaust ventilation is provided by wall- or ceiling-mounted exhaust vents powered by rooftop fans (Picture 4). The exhaust system was functioning at the time of assessment. However, it is important to note that the location of some exhaust vents can limit exhaust efficiency. In some areas, the exhaust ventilation function is hindered by the proximity of vents to hallway doors (Picture 5). When classroom doors are open, exhaust vents will tend to draw air from both the hallway and the classroom, reducing the effectiveness of the exhaust vent to remove common environmental pollutants. Without sufficient supply and exhaust ventilation, environmental pollutants can build up, leading to indoor air quality/comfort complaints.

Wall-mounted exhaust

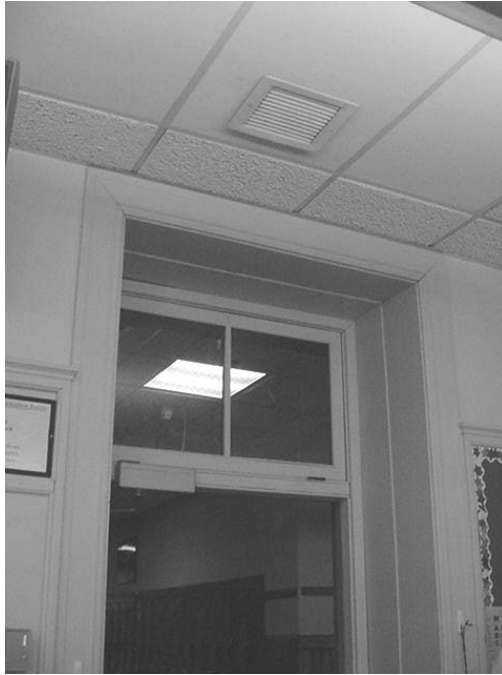
Picture 5

Exhaust vent located above hallway door

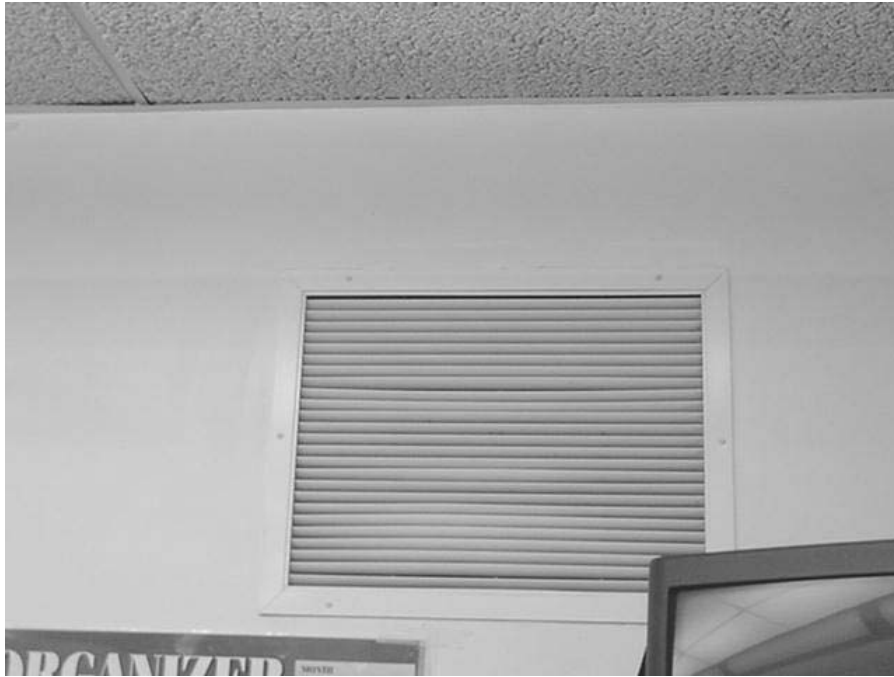
Picture 7

Also of note is room 119, which is a former wood working shop that was converted into a classroom. The former shop relied heavily on pressurization for ventilation and air exchange. A passive vent is located on the wall shared with the hallway (Picture 7). A switch activated exhaust vent is located on the wall opposite the passive vent (Picture 8). When the shop was in session, the switch would open the exhaust louvers to allow pollutants to exhaust out of the building. The exhaust vent appeared to not have been activated for some time, as evidenced by boards that were placed on the outside to prevent use. In addition to this exhaust, a localized mechanical exhaust vent was observed above the doorway to the classroom (Picture 9). This ceiling exhaust is also switch activated. At the time of the assessment, this exhaust was not activated.

Passive wall vent in room 119

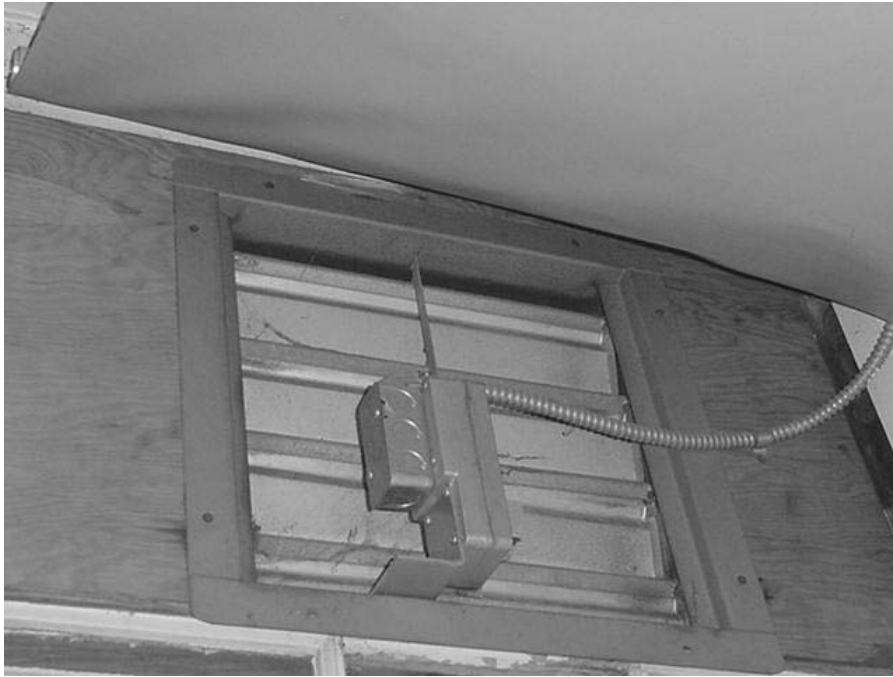
Picture 8

Switch activated wall exhaust

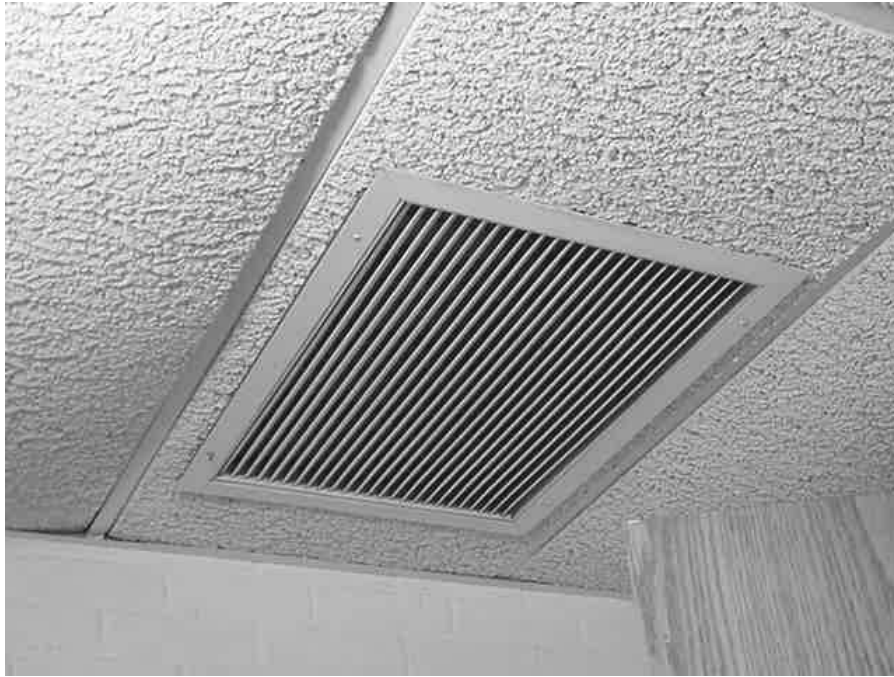
Picture 9

Switch activated local ceiling exhaust

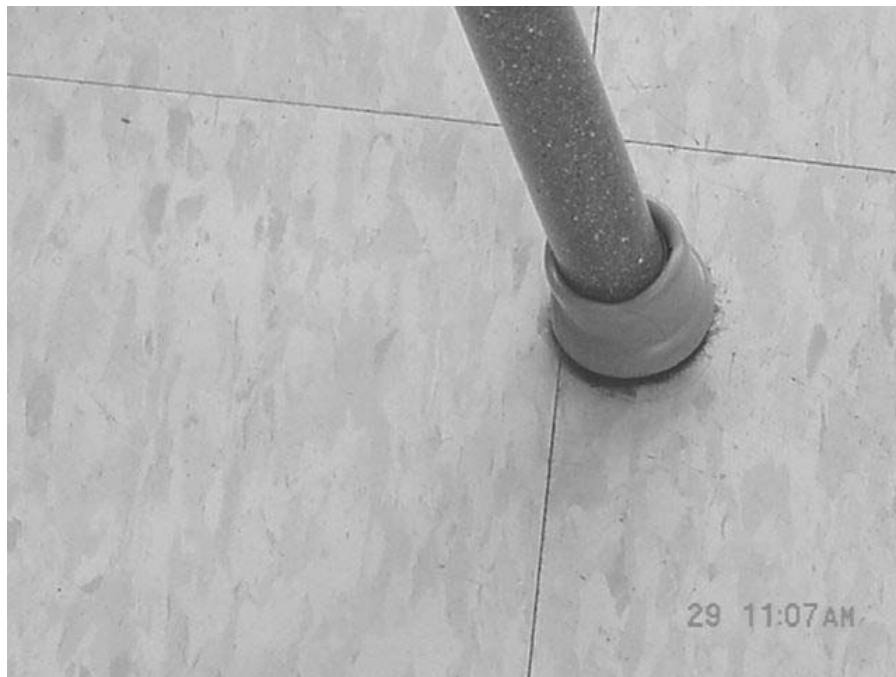
Picture 42

“Glides” on bottom of chair legs

Alternative solutions to tennis balls include glides (Picture 42), which are plastic boots with felt bottoms that can be placed on chair legs.
